Manhole Inspection Summary

Manhole # S19AA_026MH

Location Address: **2100 PULASKI ST**

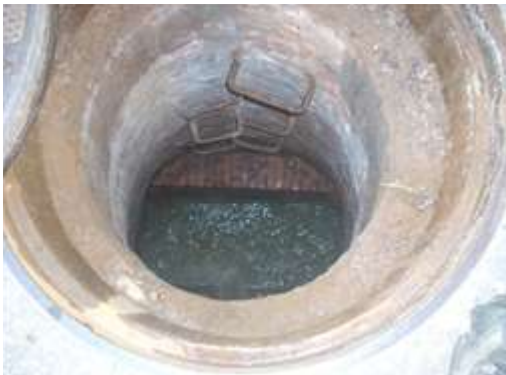
Defect 1

Count: **6** Missing: **0** ☒ **Corroded**

CORRODED STEPS

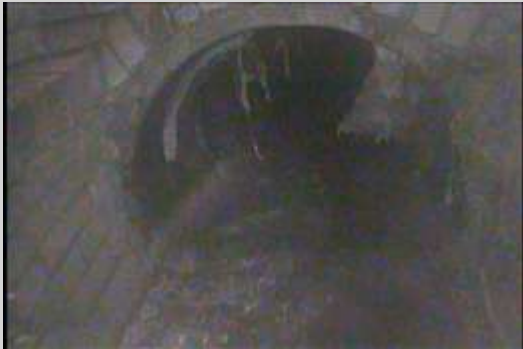
12 O'Clock Outflow

27 in. Circular Gravity Sewer
Pipe Out @ 12 O'Clock

Pipe Height: **27.6** (in.) Rod and Bar (Angled)
Pipe Material: **Clay** ☐ Pipe Lined
Invert Depth: **12.06** (ft.) Flow Characteristics: **Slow**
Deposits: ☒ None ☐ Mud ☐ Sludge ☐ Debris ☐ Grease
Silt Depth: (in.) Deposits Extent:
Infiltration: **None** Pipe Seal Cond: **Sound**

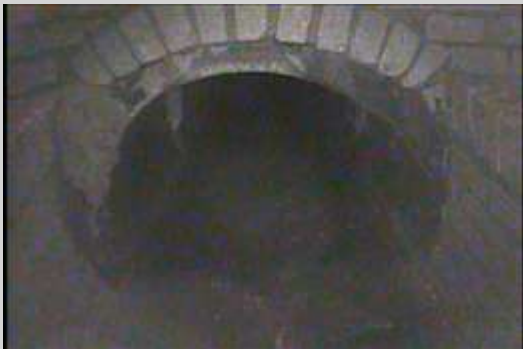
6 O'Clock Inflow

27 in. Circular Gravity Sewer
Pipe In @ 6 O'Clock

Pipe Height: **27.6** (in.) Rod and Bar (Angled)
Pipe Material: **Clay** ☐ Pipe Lined
Invert Depth: **12.01** (ft.) Flow Characteristics: **Slow**
Deposits: ☒ None ☐ Mud ☐ Sludge ☐ Debris ☐ Grease
Silt Depth: (in.) Deposits Extent:
Infiltration: **None** Pipe Seal Cond: **Sound**

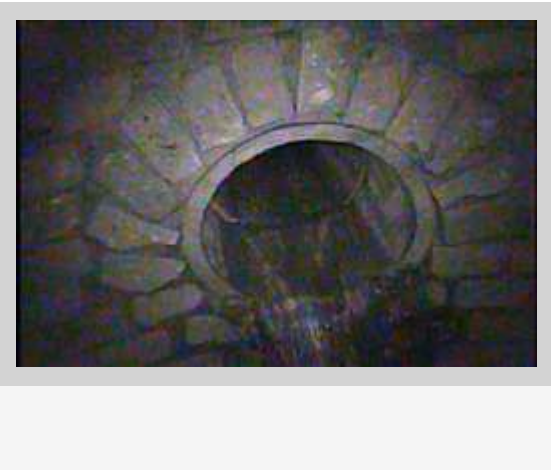
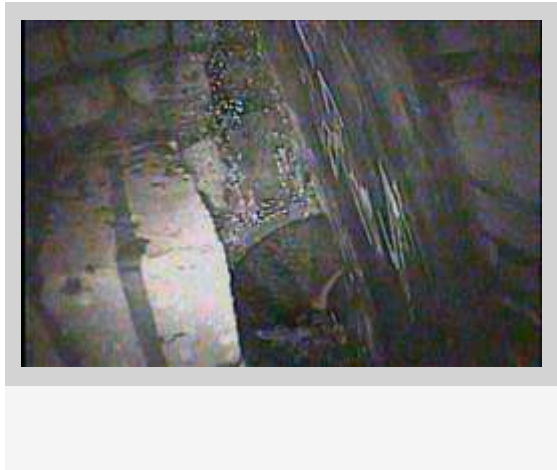
9 O'Clock Inflow
Drop In @ 9 O'Clock

10 in. Circular Gravity Sewer
Pipe In @ 9 O'Clock

Pipe Height: 10.8 (in.) Rod and Bar (Angled)
Pipe Material: Clay ☐ Pipe Lined
Invert Depth: 10.10 (ft.) Flow Characteristics: Slow
Deposits: ☐ None ☐ Mud ☒ Sludge ☒ Debris ☐ Grease
Silt Depth: 4 (in.) Deposits Extent: Medium
Infiltration: None Pipe Seal Cond: Sound

Drop: Outside	Rod and Bar
Angled: Yes	Reading: 10.05 (ft.)
	Inv Depth: 11.05 (ft.)
Drop Condition: Clogged	
Connects To: Manhole	
<input type="checkbox"/> Possible Illicit Connection
